Locomotive Collision Test #1

Inline Collision of a Freight Locomotive with a Stationary Hopper Consist

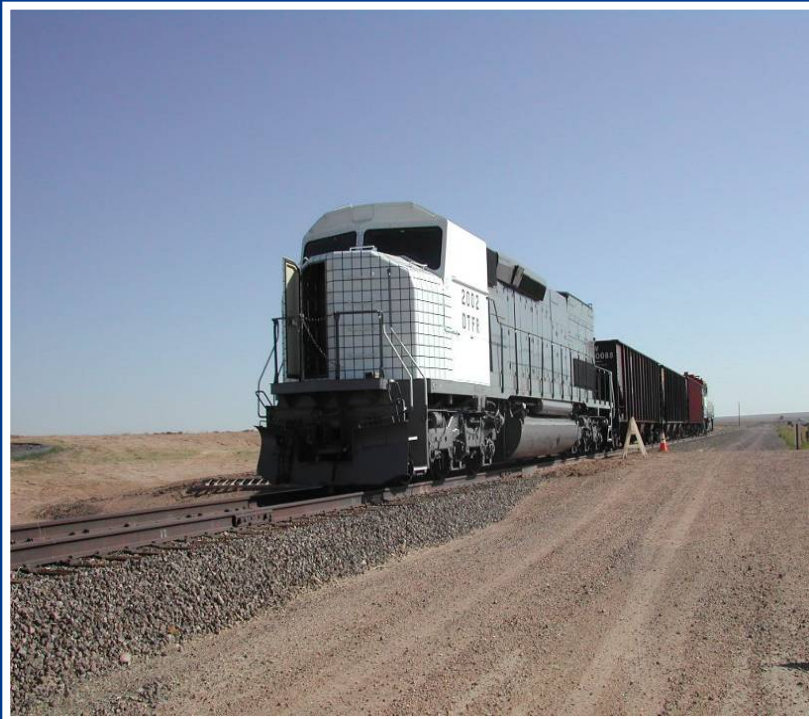
Bullet locomotive and
trailing hopper cars

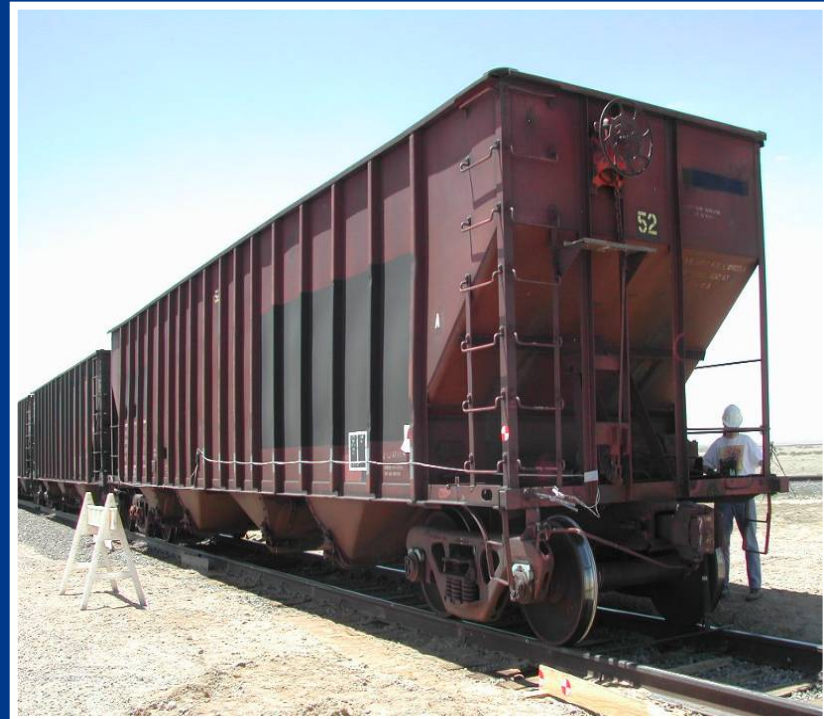
Stationary hopper car

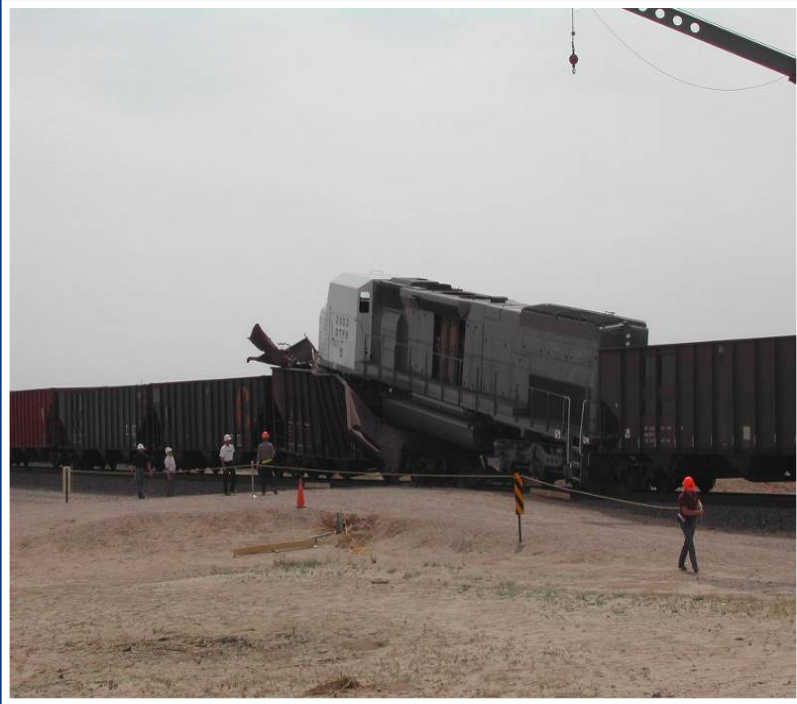
Position of locomotive
following collision test

- What did we learn from this test?
 - Even at low speeds (~30 mph), the locomotive can override stationary vehicles
 - Anticlimber and collision posts did not directly affect the outcome of this collision
 - End plate and draft gear pocket formed a ramp that allowed the locomotive to ride up on top of the comparatively weaker hopper structure
 - Hopper body provided no resistance to locomotive override

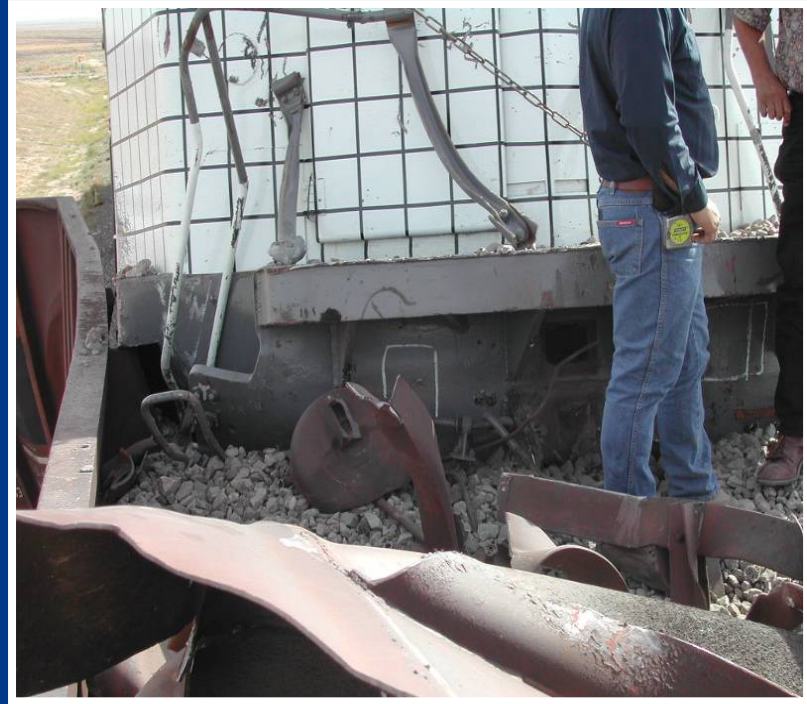
View of locomotive front end
buried in hopper car debris

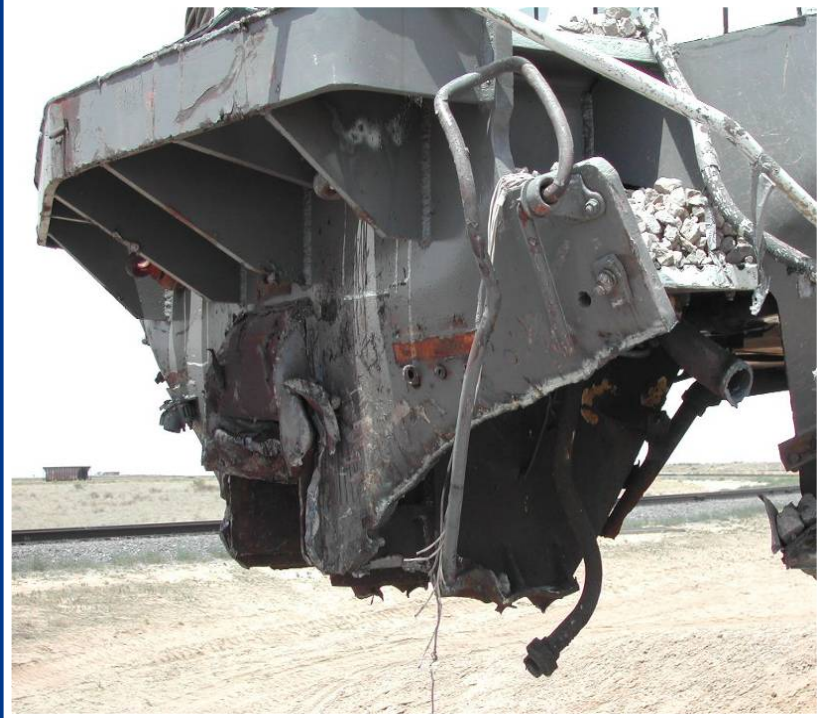
Extensive damage to end plate and draft gear pocket
